Manhole Inspection Summary

Manhole # S29K__064MH

Insp Date: **1/27/09 12:39 PM**

Location Address: **645 Bankard LN**

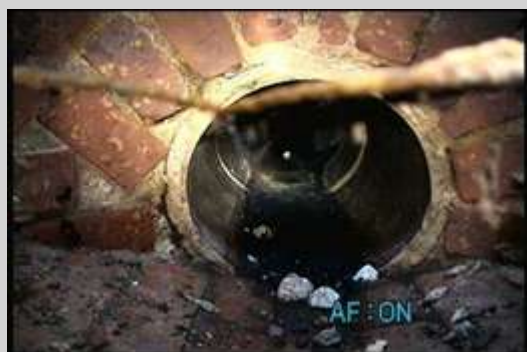
12 O'Clock Outflow

8 in. Circular Gravity Sewer
Pipe Out @ 12 O'Clock

Infiltration: **None** Pipe Seal Cond: **Sound**
